To:	Michael Chelminski	From:	Rick Schultz
	Topsham ME Office		Topsham ME Office
File:	Field Observation Report	Date:	October 14, 2012

### **Reference: Orland Village Dam – Condition Assessment**

# ORLAND VILLAGE DAM

## FIELD SKETCHES

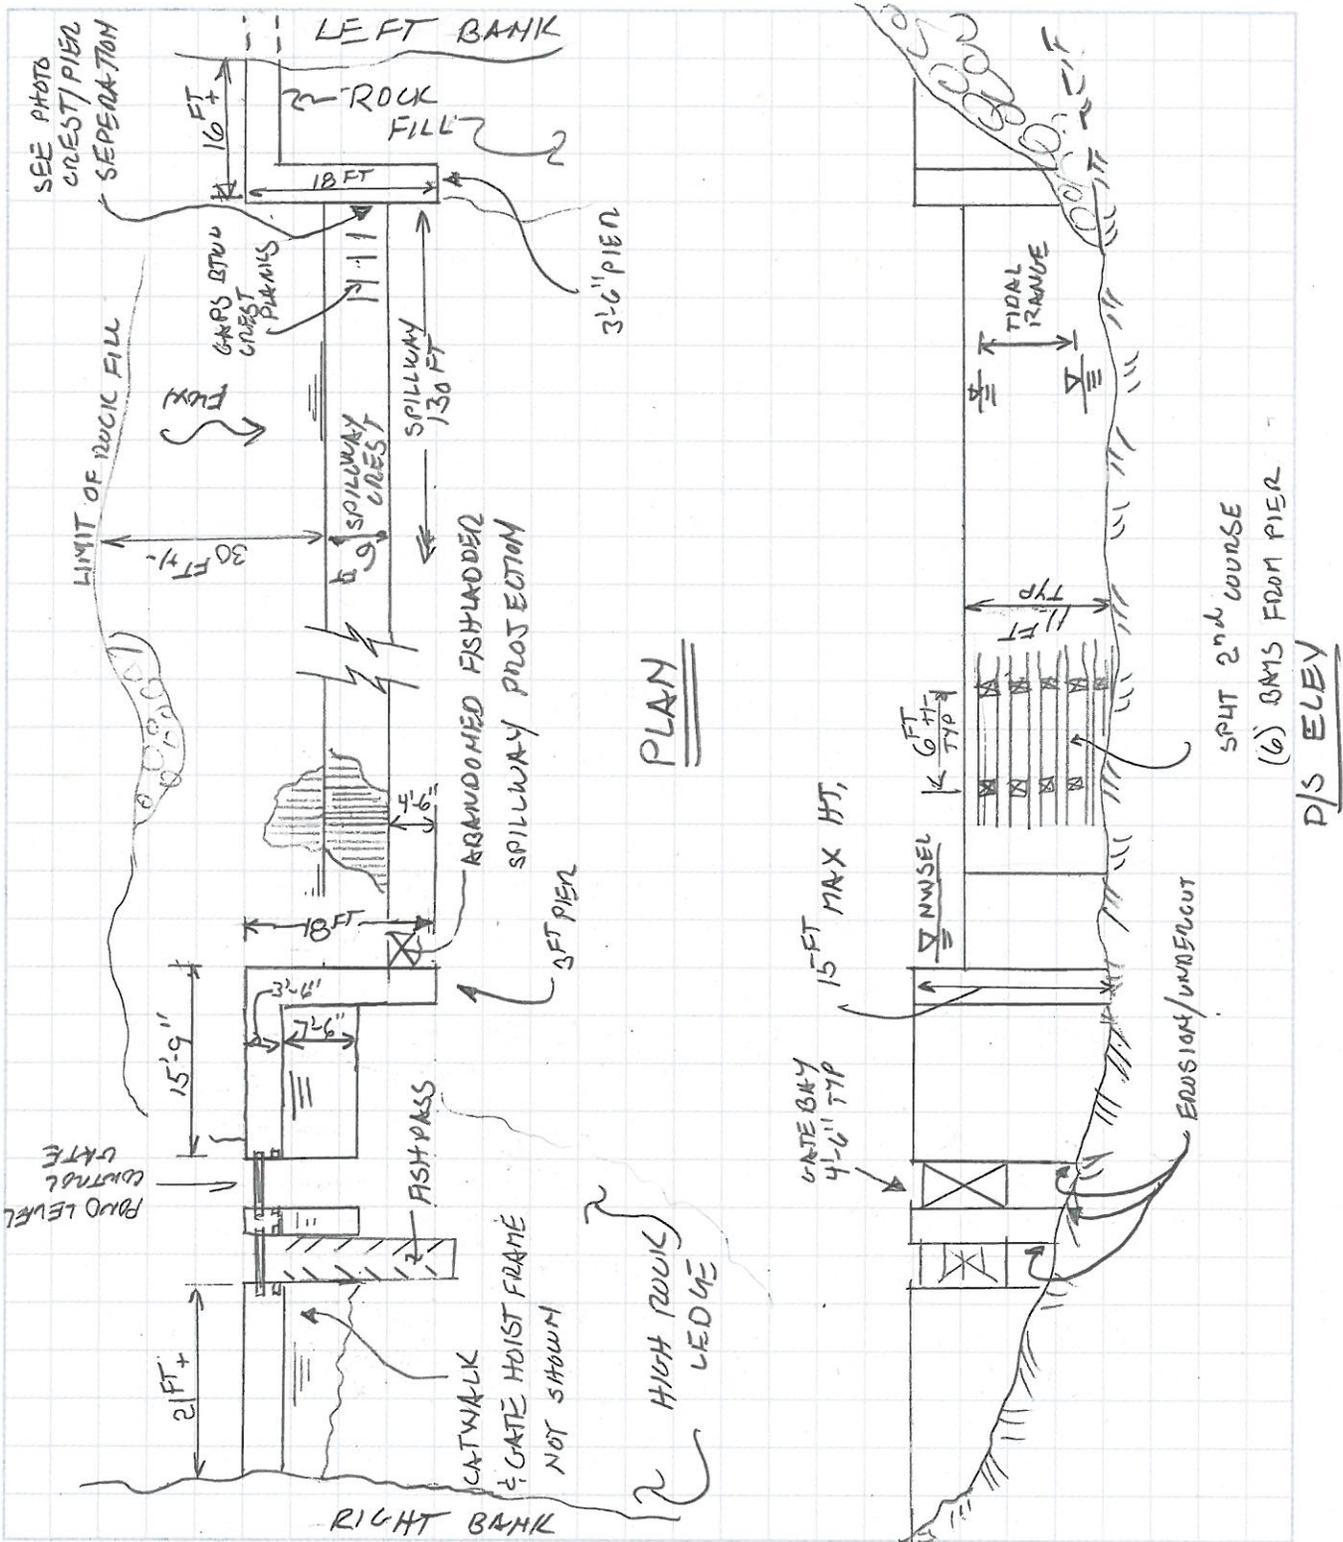
The timbers and rock ballast condition appears good and stable. No large voids in the ballast or crib bays that appear partially filled cribs were observed. The crib members and connections show good alignment, deterioration of timber surface appears uniform, and only one moderate split was noted at the location shown on attached sketches. The timbers exhibit raised grain and uniform

The left abutment is a retaining wall type structure built into the left embankment. The concrete appears to be in good condition, but there are signs of instability which should be monitored. Recent rock fill has been placed adjacent to and downstream of the abutment which indicates historic seepage around the abutment. There is separation between the abutment face and spillway timbers (see attached photo), and there are gaps between the spillway planks over a 20-foot-length of spillway crest. These observations suggest that the abutment has moved toward the embankment or the spillway is pulling away from the abutment<sup>3</sup>.
